Garmon Home Inspection Services, Inc.
P.O. Box 923792
Norcross, GA 30010

Peachtree Battle Ave.
Atlanta, Ga 30305

File Number Peachtree Battle Ave. 092007

Inspection Date 09/20/2007

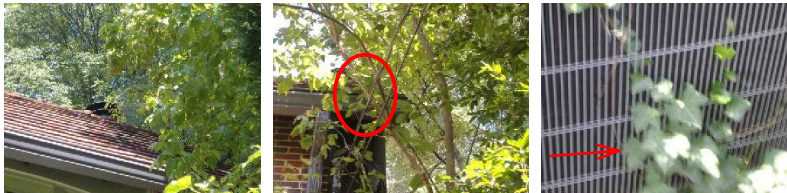
6. Vegetation: Grass, shrubbery and trees a. Shrubby to close to main structure and outbuilding, A/C units and tree limbs close to structure.
b. Tree limbs rub electric service line.

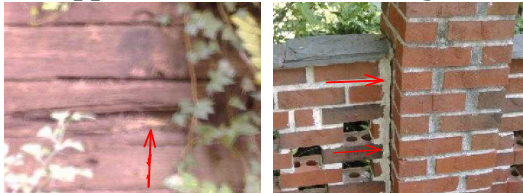
7. Retaining Walls: Brick and crosstie, stone and stucco a. Some deterioration at crosstie at right exterior, add ivy blocked full view, did not view tie backs.
b. Noted brick joint cracks at right brick privacy wall.
c. Noted some stucco cracks at back retaining wall at garage and missing a guardrail at top of wall.
d. Missing handrails at landscape stairs and guardrail at wall around pool area and gate opens over stairs at back of pool.
e. Appears some retaining walls missing weep holes.

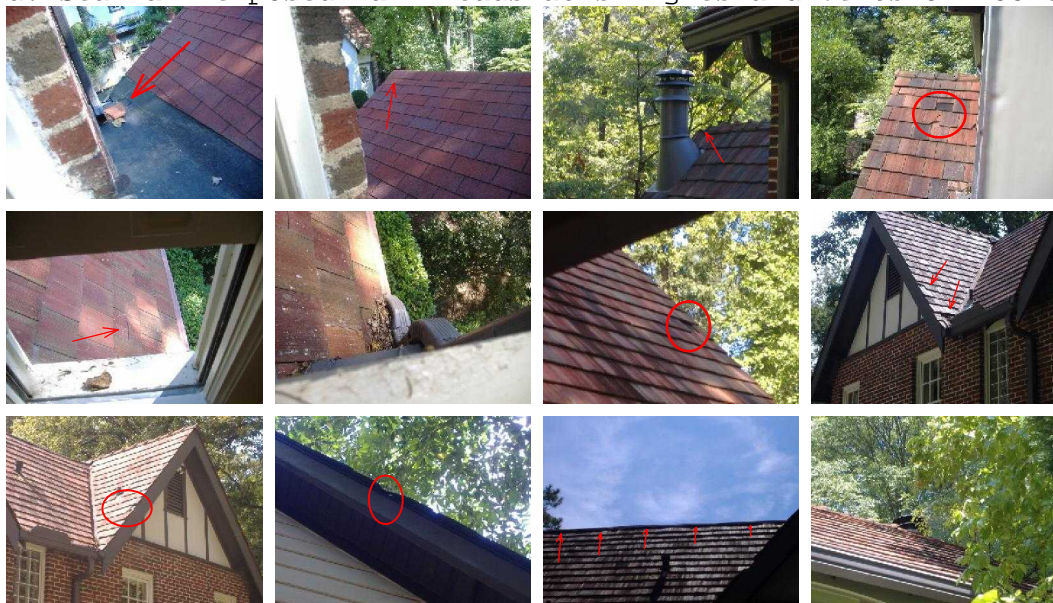
1. Method of Inspection: Ground level
2. Unable to Inspect: 50% Height of roof, Steep roof pitch
3. Material: Celadon ceramic slate and asphalt shingles a. Noted several cracked loose and missing roof tiles, recommend qualified contractor to monitor entire roof and insure all needed repairs are corrected to prevent water entry, noted several pictures of areas.
b. Missing a ridge shingle at right side of house at fireplace flue.
c. Appears asphalt shingle material was used to form at ridge cover noted at back center roof, may have exposed nail heads.
d. Seal all exposed nail heads at shingles and vents on roof.

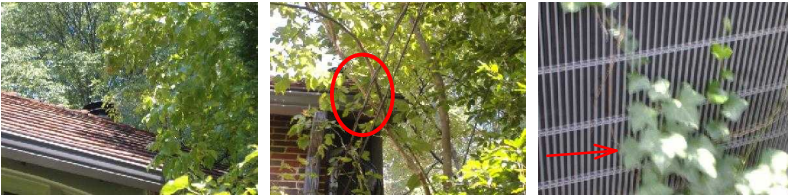
3. Vegetation: Grass, shrubbery and trees
 - a. Shrubby to close to main structure and outbuilding, A/C units and tree limbs close to structure.
 - b. Tree limbs rub electric service line.

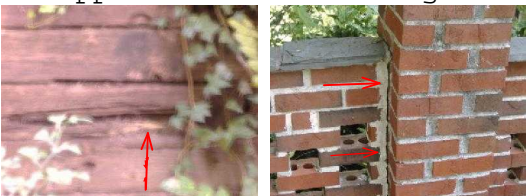
4. Retaining Walls: Brick and crosstie, stone and stucco
 - a. Some deterioration at crosstie at right exterior, add ivy blocked full view, did not view tie backs.
 - b. Noted brick joint cracks at right brick privacy wall.
 - c. Noted some stucco cracks at back retaining wall at garage and missing a guardrail at top of wall.
 - d. Missing handrails at landscape stairs and guardrail at wall around pool area and gate opens over stairs at back of pool.
 - e. Appears some retaining walls missing weep holes.

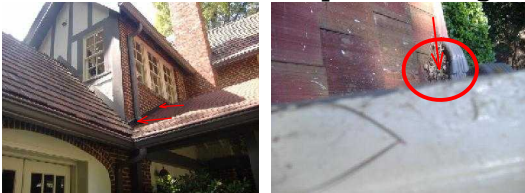
19. **Flashing:** Not fully visible Flashing was painted could not fully view.
a. All flashing material that meets brick should be galvanized material and some sidewall flashing was not properly step flashed.
b. Missing kickout flashing where roof meets vertical walls to divert water and debris to gutters.
c. Noted some valley flashing used where roof meets sidewall, should be step flashed.

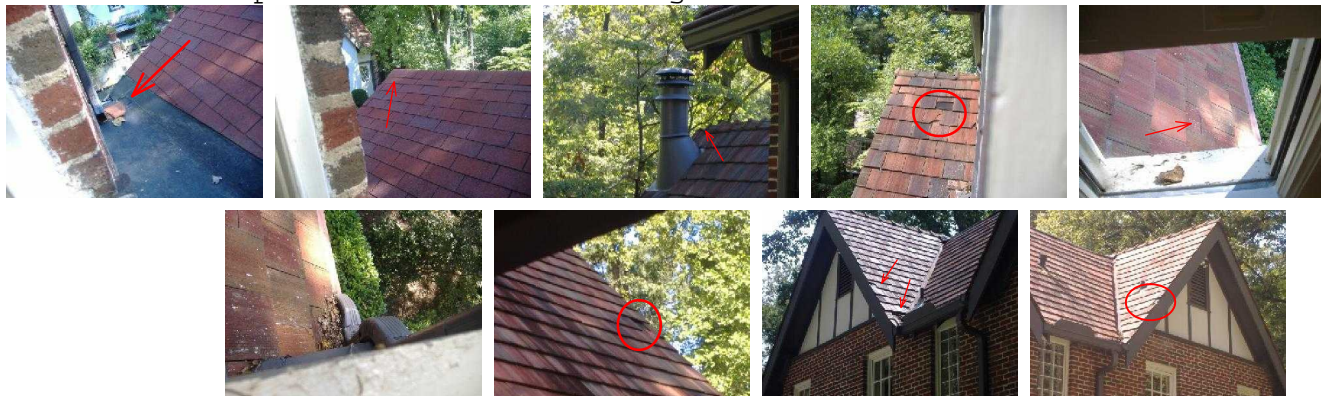
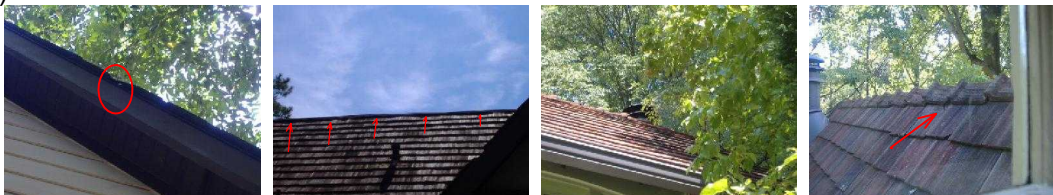
6. **Main roof Roof Surface Material:** Celadon ceramic slate and asphalt shingles a. Noted several cracked loose and missing roof tiles, recommend qualified contractor to monitor entire roof and insure all needed repairs are corrected to prevent water entry, noted several pictures of areas.
b. Missing a ridge shingle at right side of house at fireplace flue.
c. Appears asphalt shingle material was used to form at ridge cover noted at back center roof, may have exposed nail heads.
d. Seal all exposed nail heads at shingles and vents on roof.
